BMCS-LEG Comments on Coalpac's Response to PAC Review Submissions [CRPRS]

PART 3

APPENDIX 'A'

Plates 5-11 to accompany the submission entitled
BMCS-LEG Comments on
Coalpac's Response to PAC Review Submissions [CRPRS]

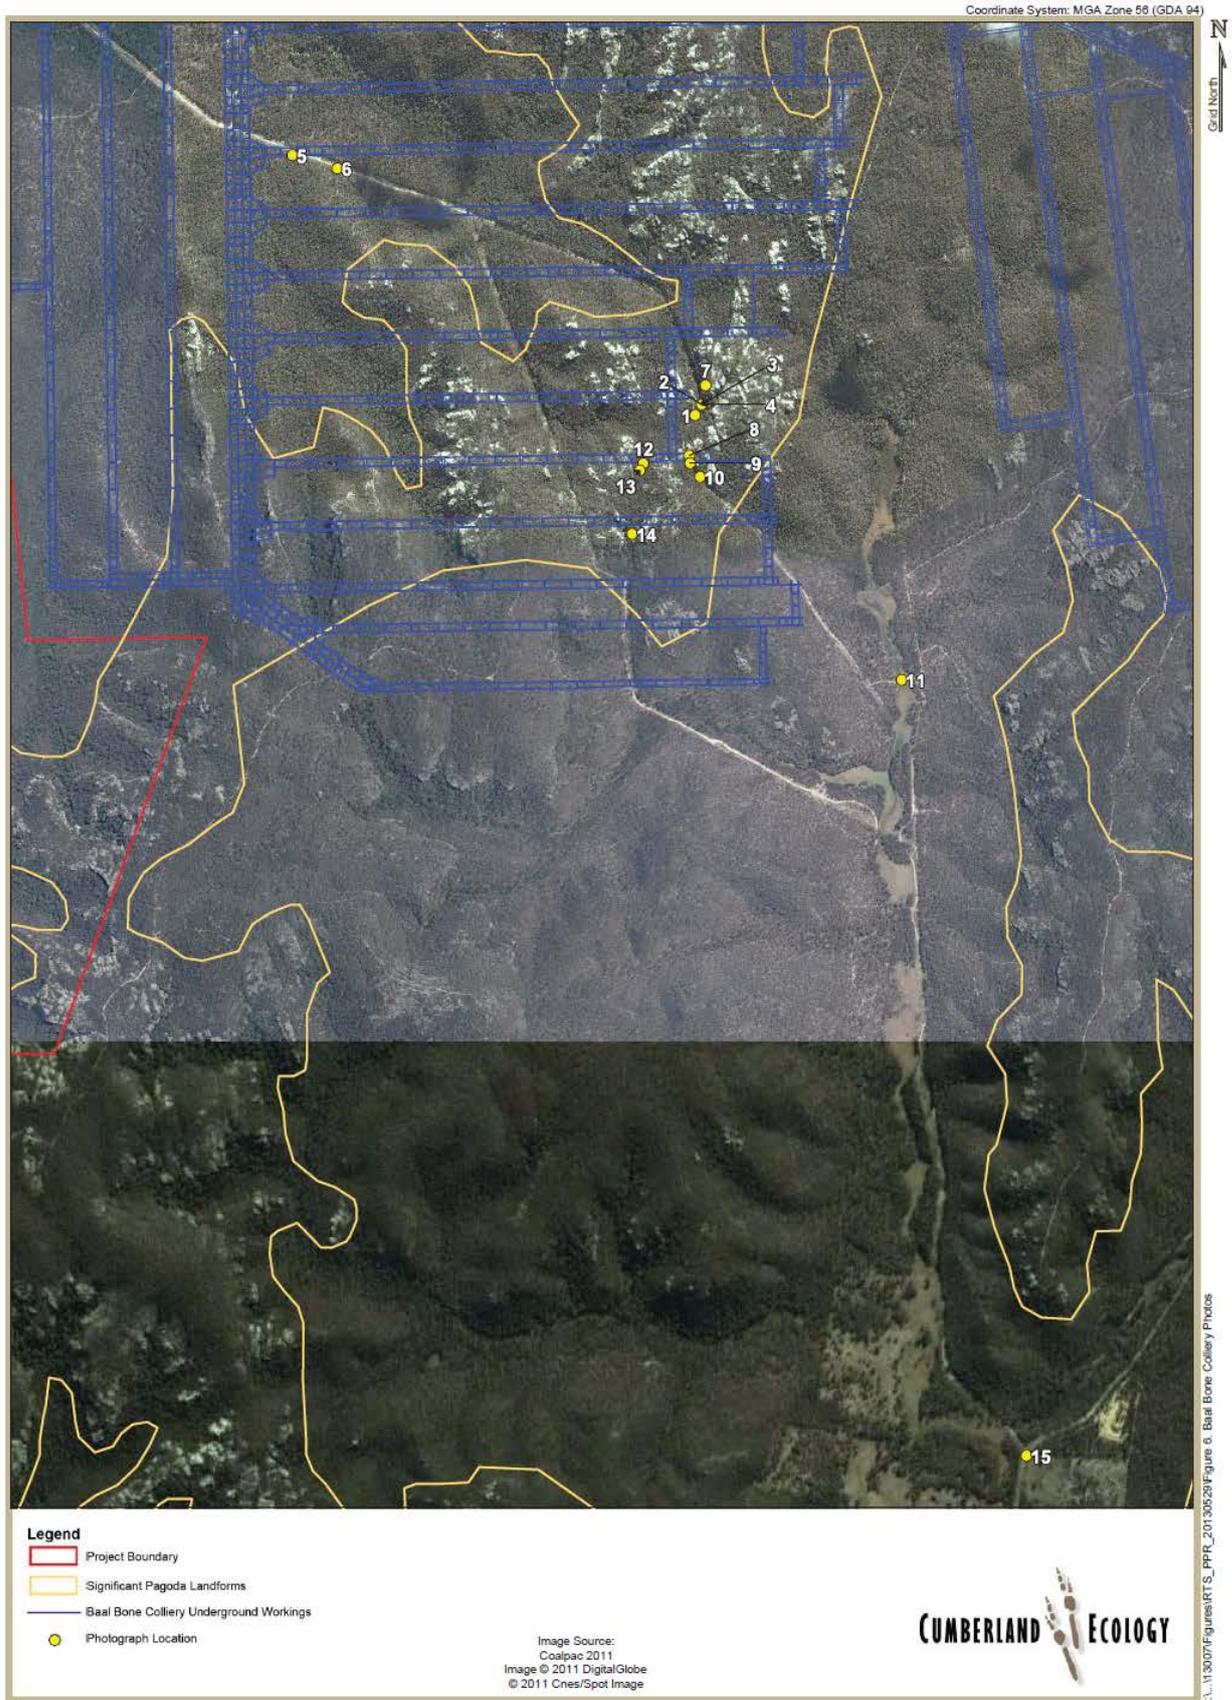
Figure 6. Baal Bone Colliery Photograph Locations

Plate 5 (Appendix A) is a copy of CRPRS Figure 6 p35. It shows the locations of a set of Plates which Coalpac uses to support its claim that the ecological damage is negligible. It is disappointing that CRPRS Plate 14 shows surface water where the main track goes through Long Swamp, seemingly with the implication that there has been no desiccation (otherwise why show it?). It is a track-formed depression which retains water after rain. The desiccation is further along the swamp.

Plate 5: *Reproduced from CRPRS p35 – it shows the location of Plates used in the CRPRS to deny the amount of subsidence-induced damage in the Baal Bone area*

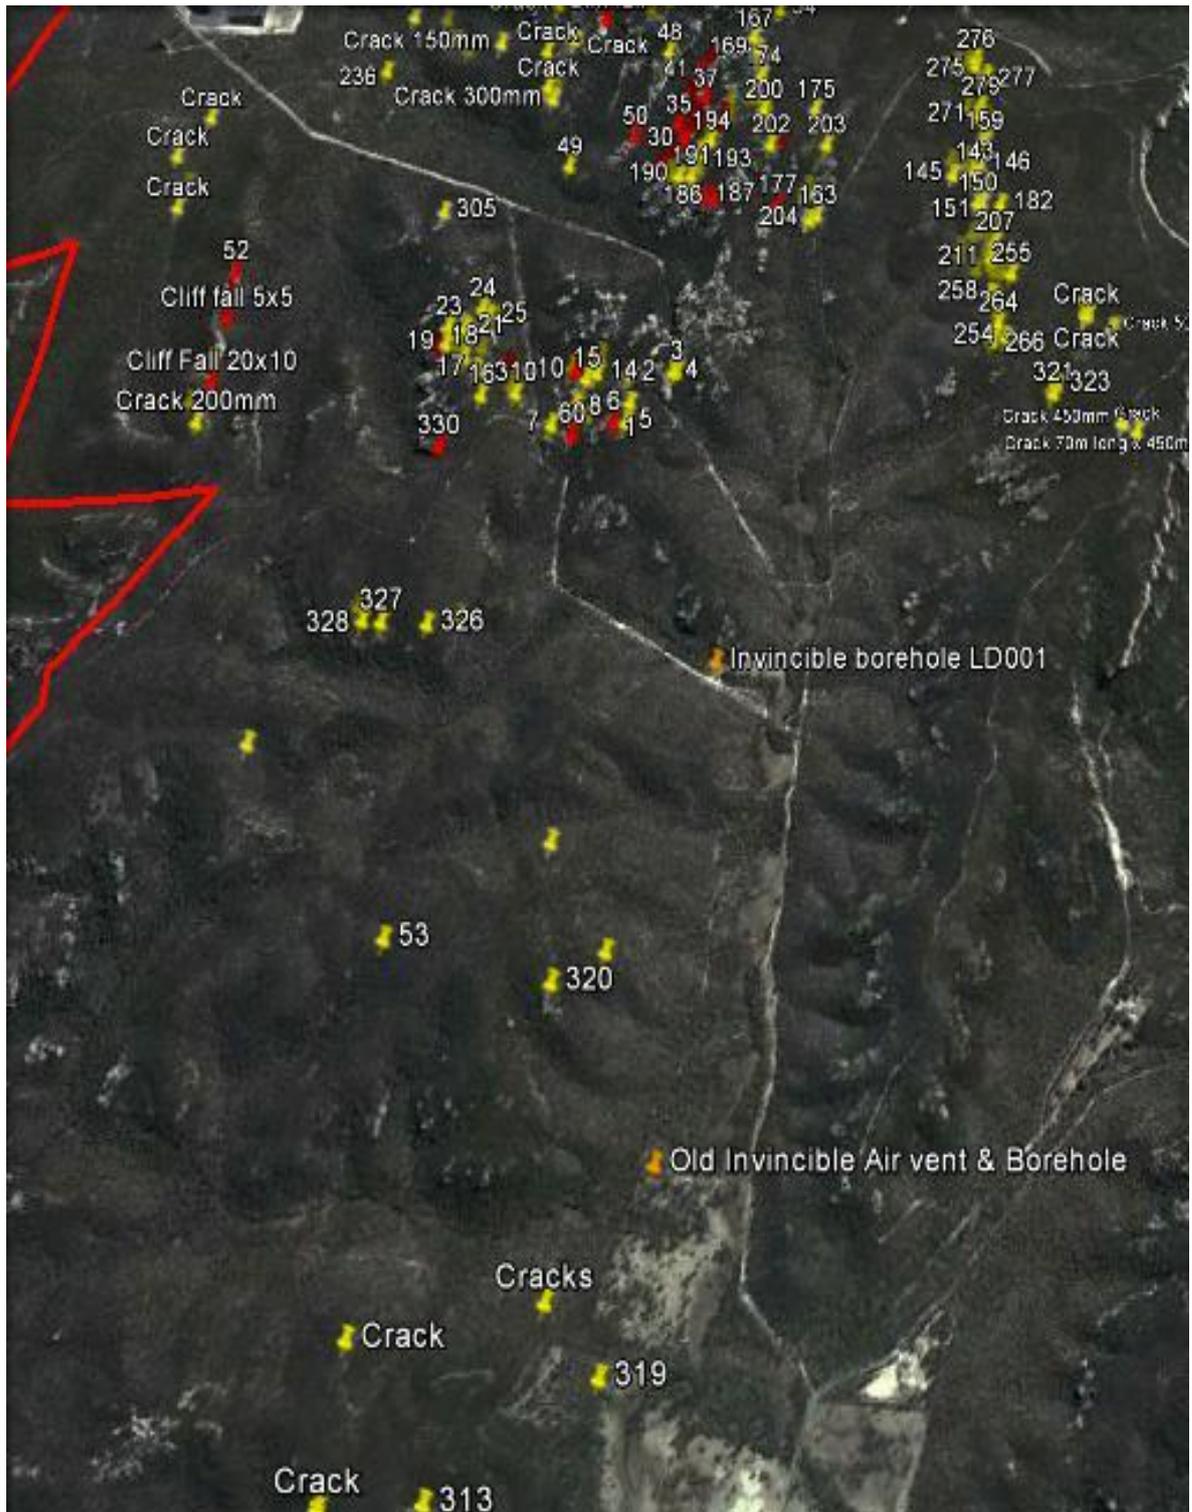
Plate 6 (Appendix A) is of the same region at approximately the same scale. It shows the substantially greater amount of damage identified by Mr Jonkers of the LEG. The numbers on the Plate correspond with those in the Table of GPS coordinates (see next paragraph and footnote 13).

Plate 6: This is approximately the same area as in Plate 5 – it shows a far higher incidence of significant cracks (yellow) and cliff collapses (red) than that observed by Coalpac and its consultant.

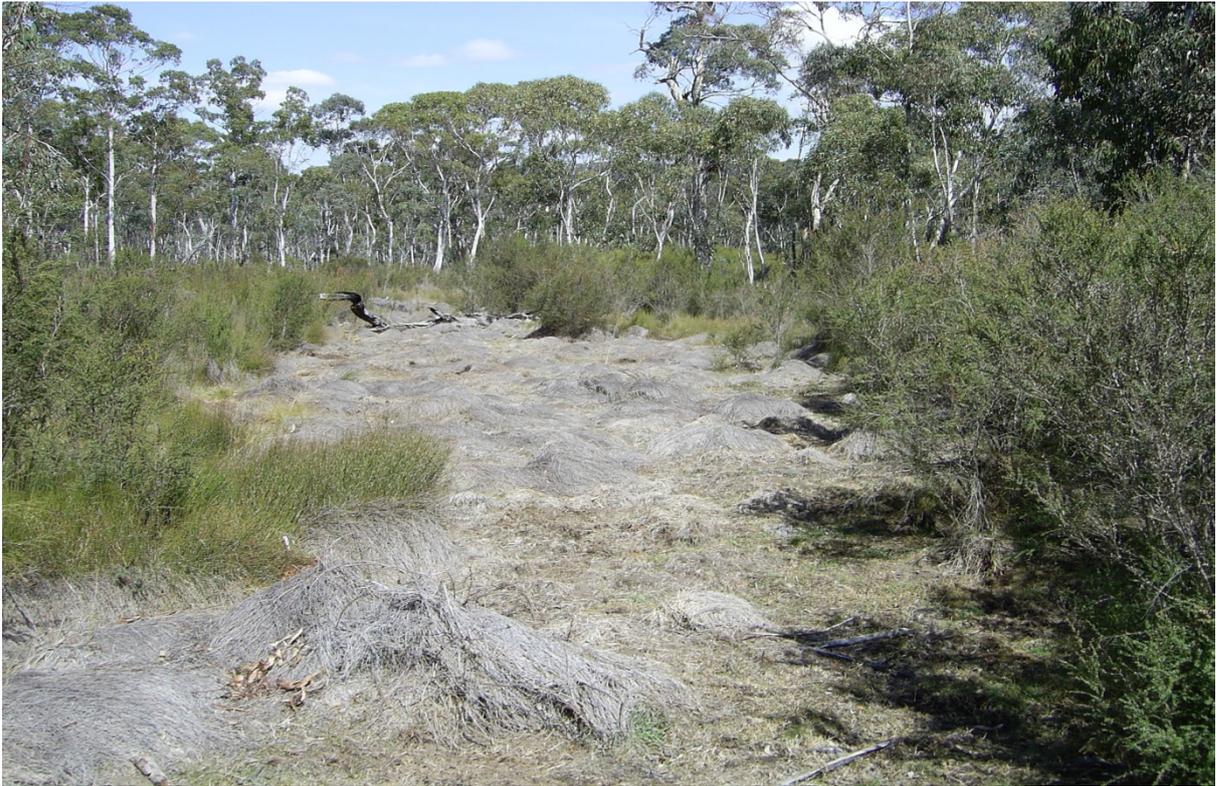
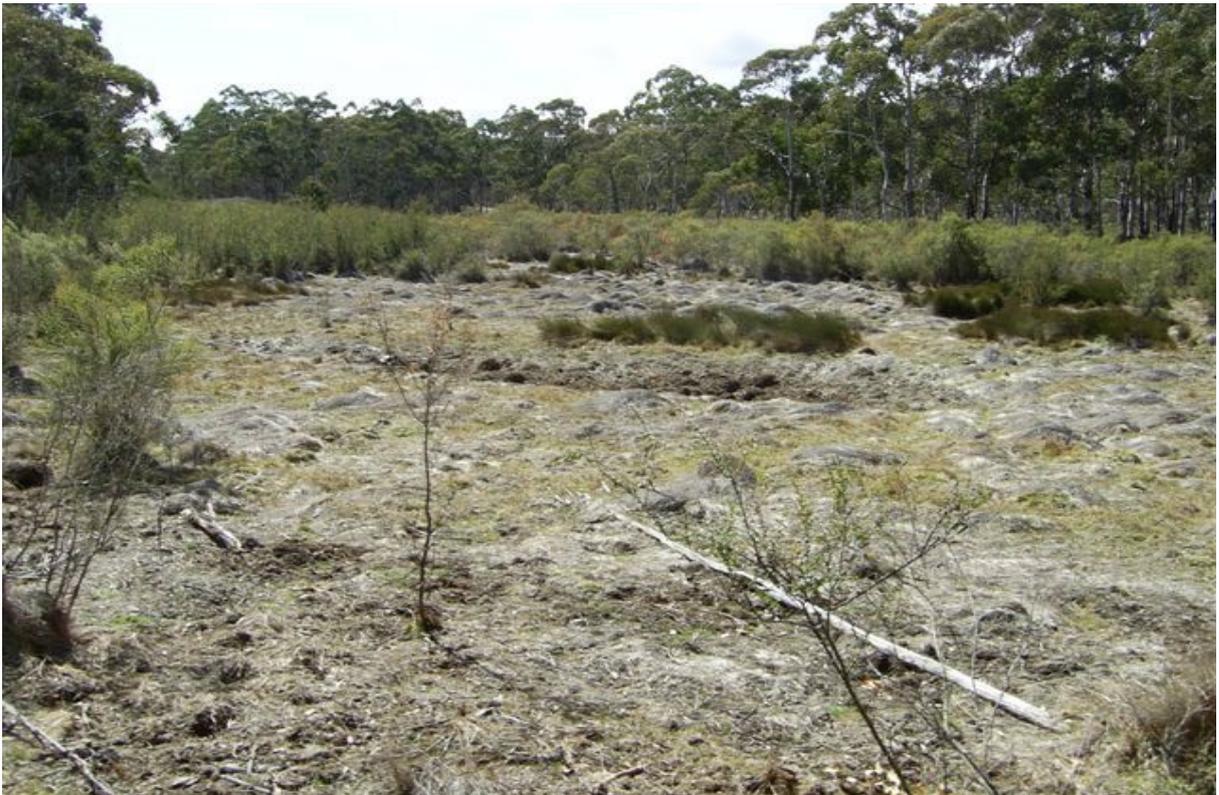
Plate 7: Two examples of desiccation in Long Swamp – somewhat different from CRPRS Plate 14 (located at point 11 on Plate 5 above) where the swamp is crossed by the track.

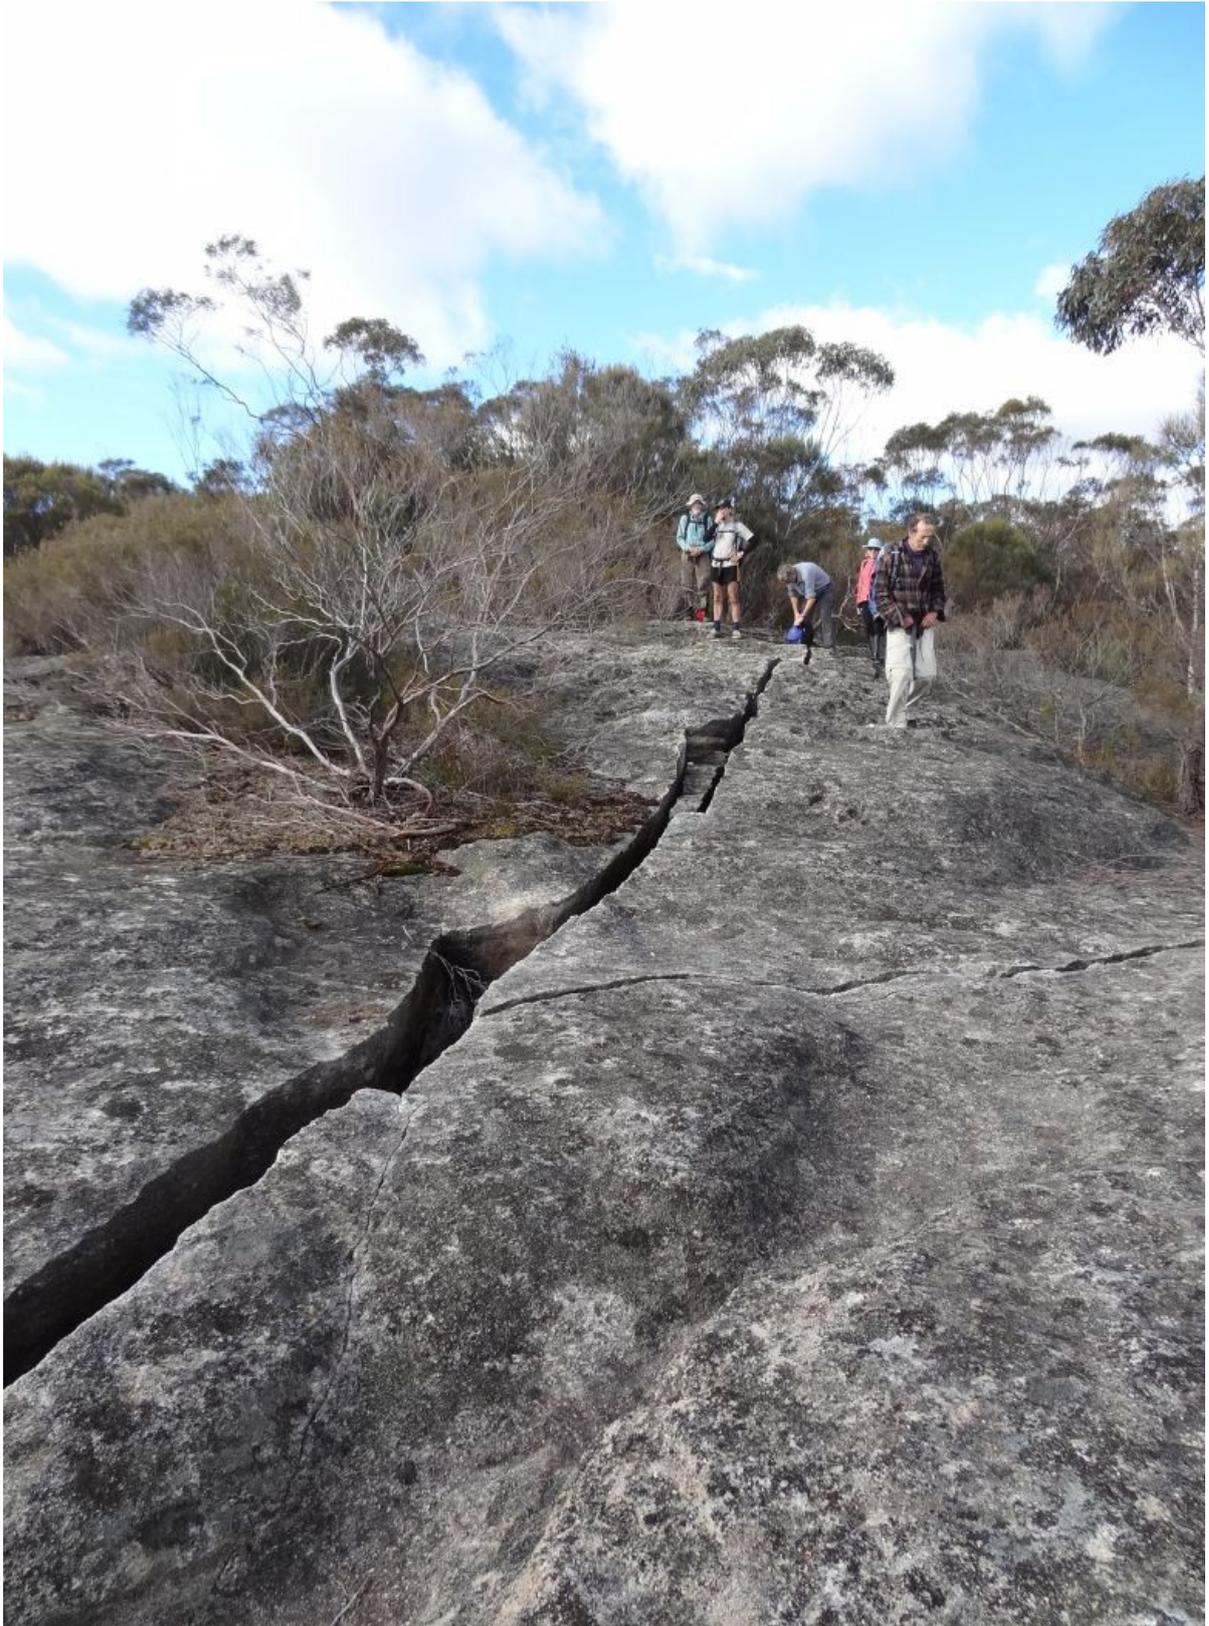
Plate 8: This is a typical example of subsidence-induced cracking – one of many examples which could have been chosen.

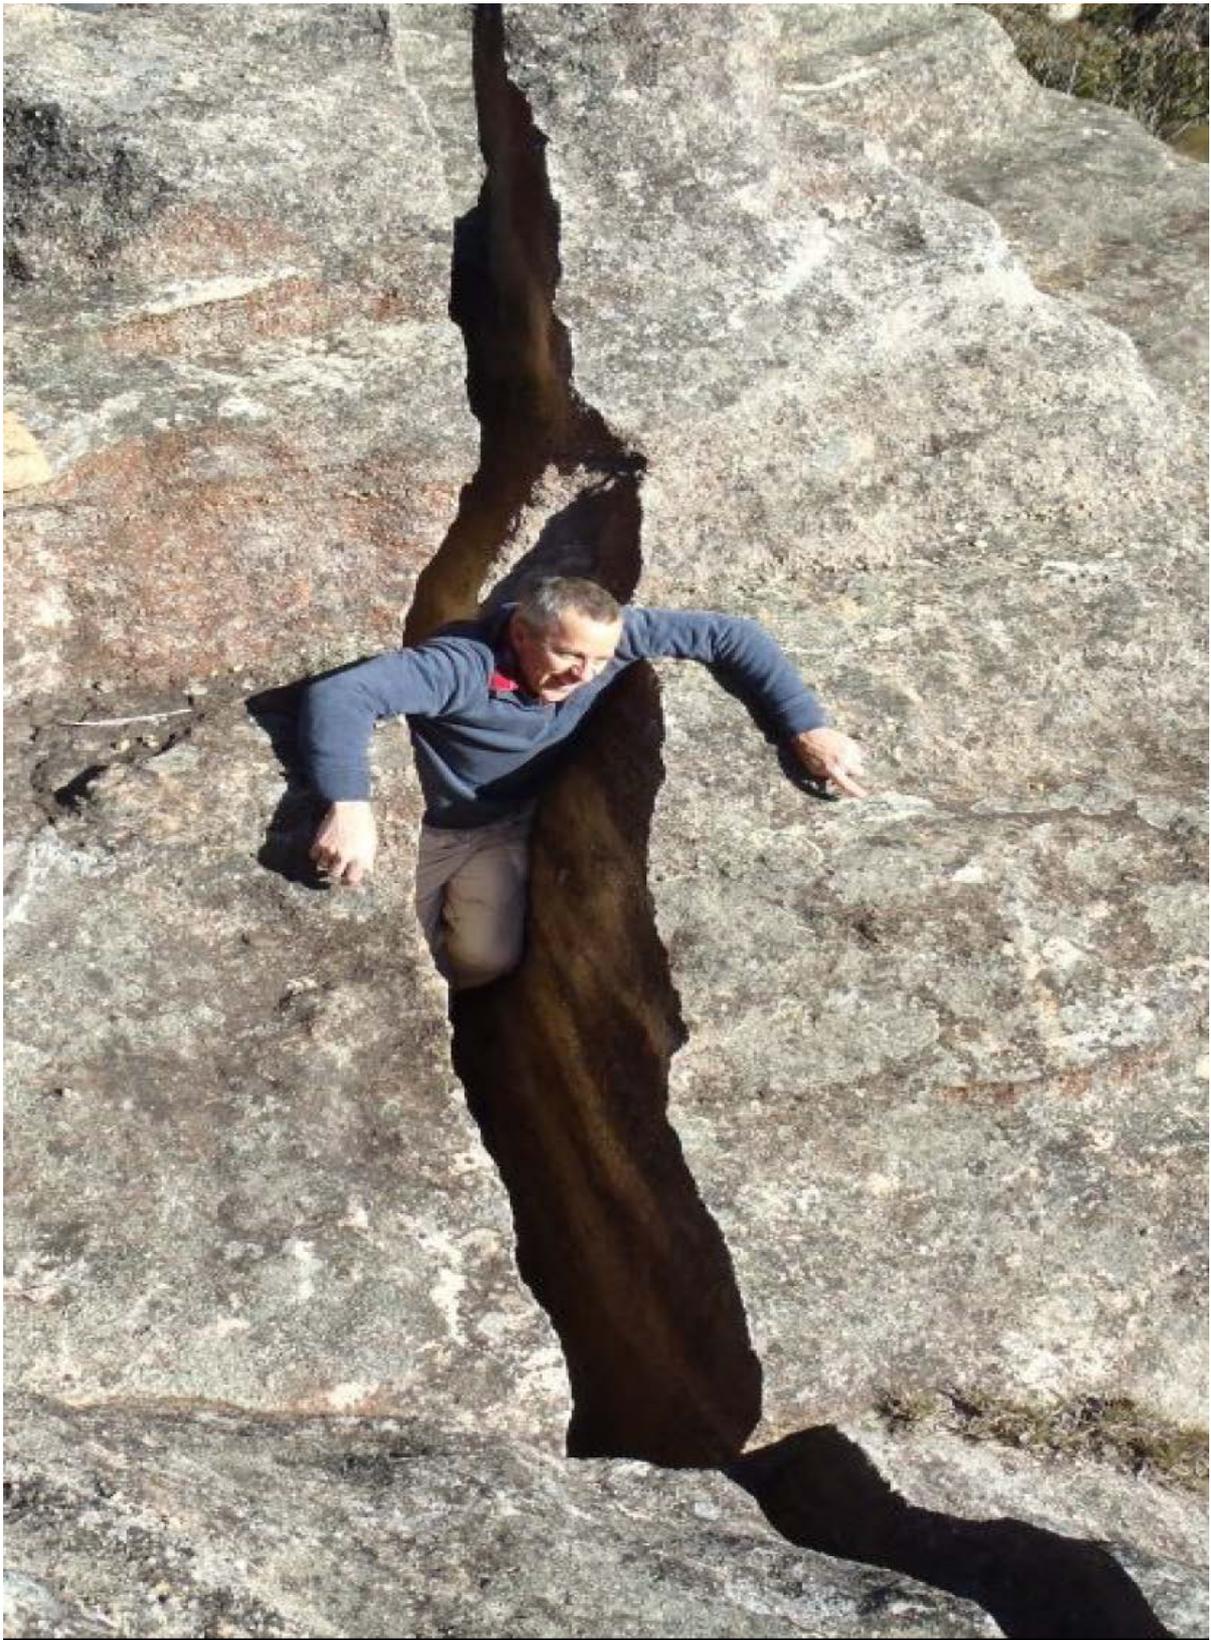
Plate 9: In this example of subsidence-induced cracking the degree of separation is substantial, but dilations exceeding 200 mm are known.

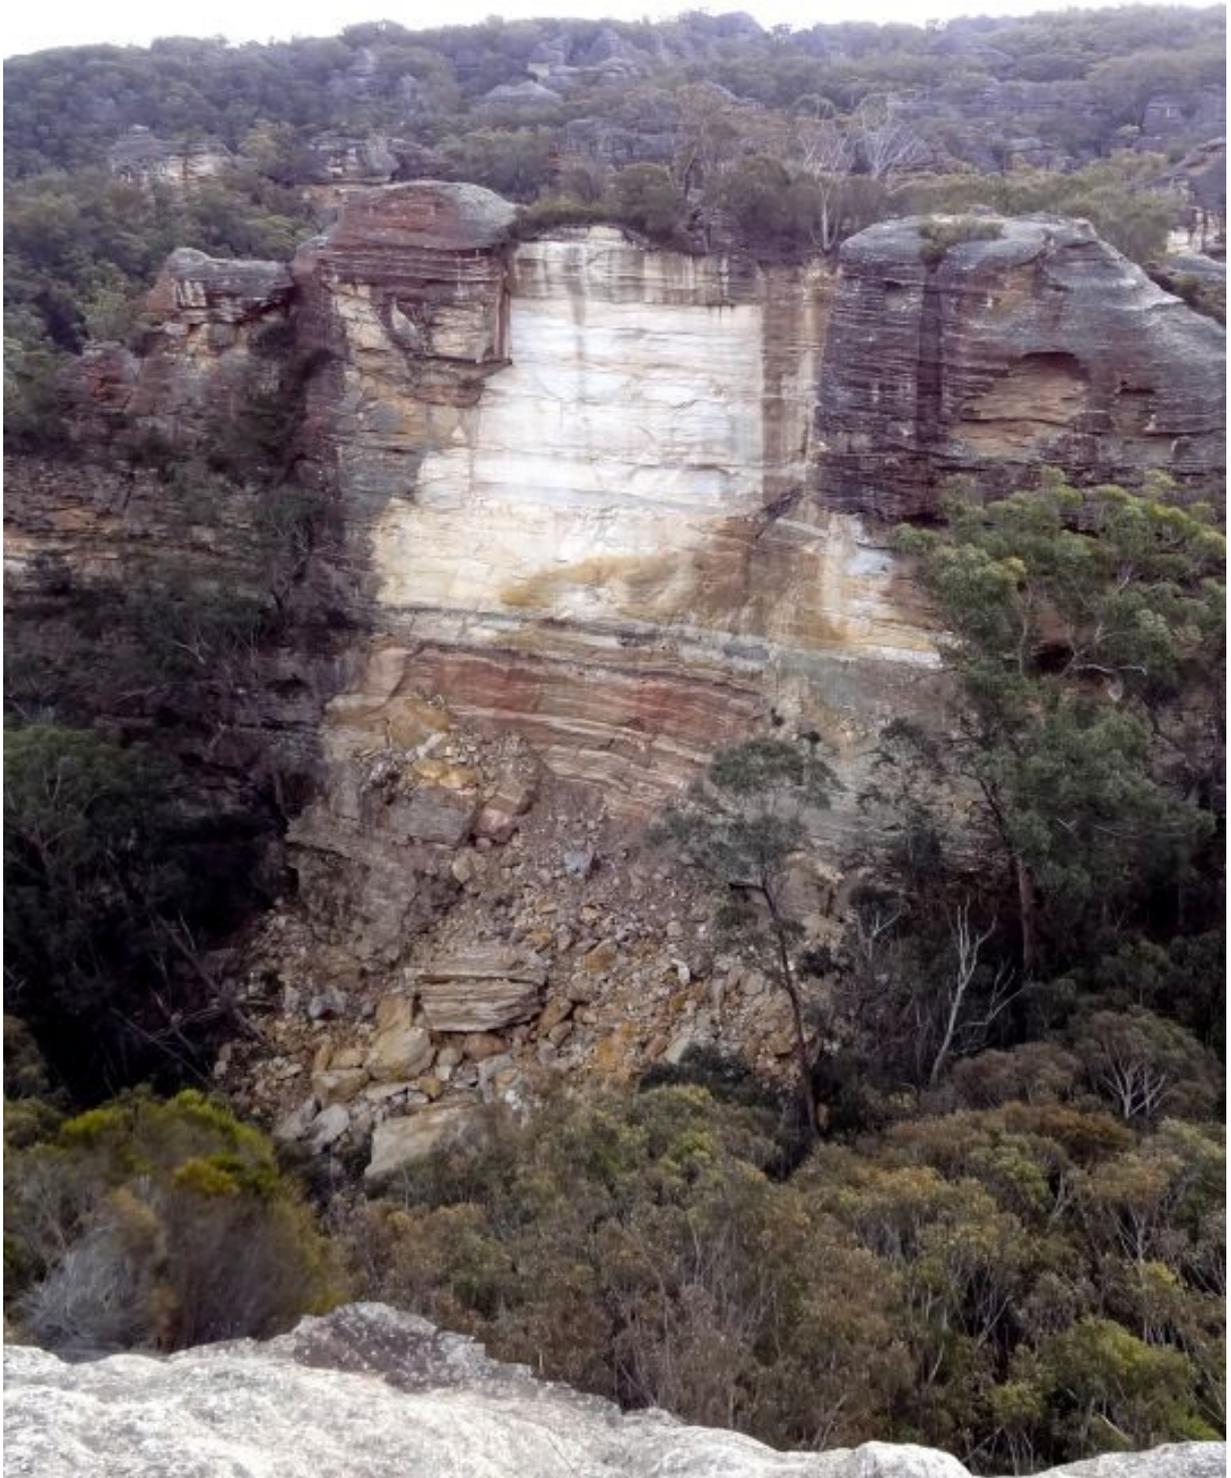
Plate 10: This cliff collapse is a typical result of cracking and ground movement leading to a rock slide. The slide material 'drowns' and destroys vegetation and habitat in its path, and covers the underlying strata.

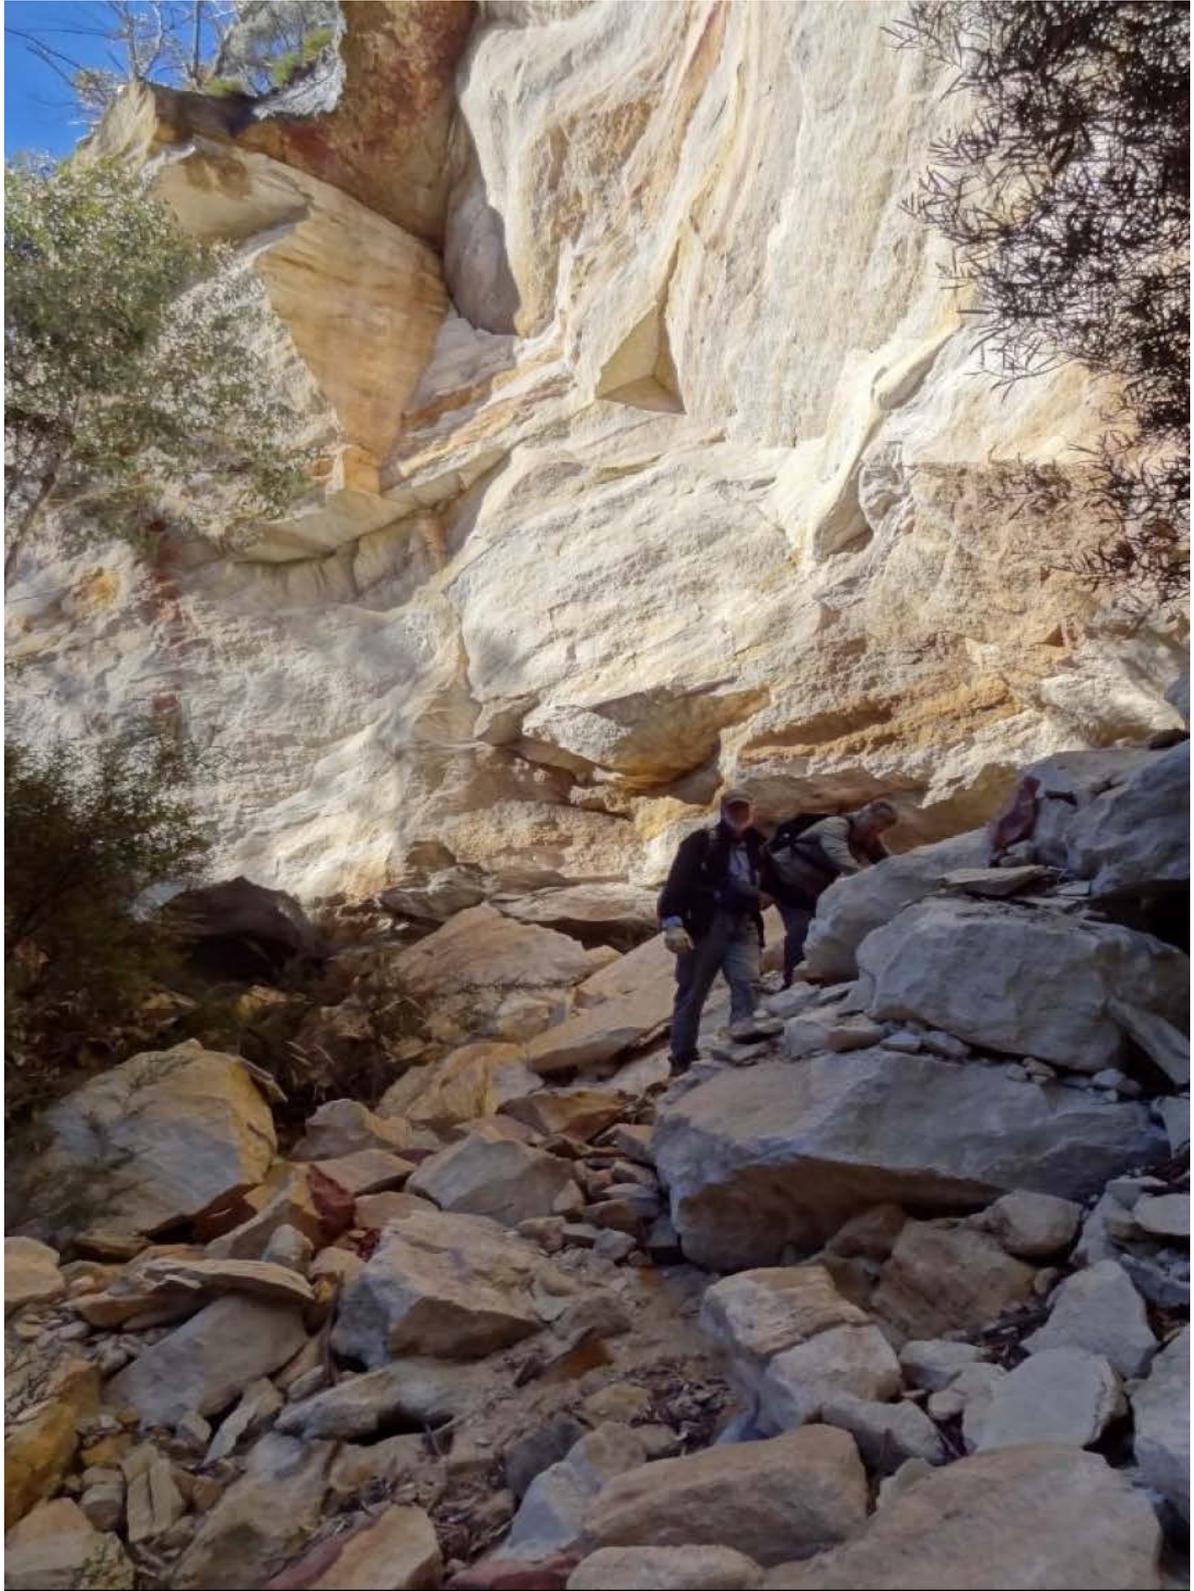
Plate 11: Another small cliff collapse showing the impact (literally) on vegetation and pre-existing habitat.
